**PRELIMINARY ASSESSMENT/
VISUAL SITE INSPECTION**

**GENERAL ELECTRIC COMPANY
MILWAUKEE, WISCONSIN
WID 000 808 725**

FINAL REPORT

**U.S. ENVIRONMENTAL PROTECTION AGENCY
Office of Waste Programs Enforcement
Washington, DC 20460**

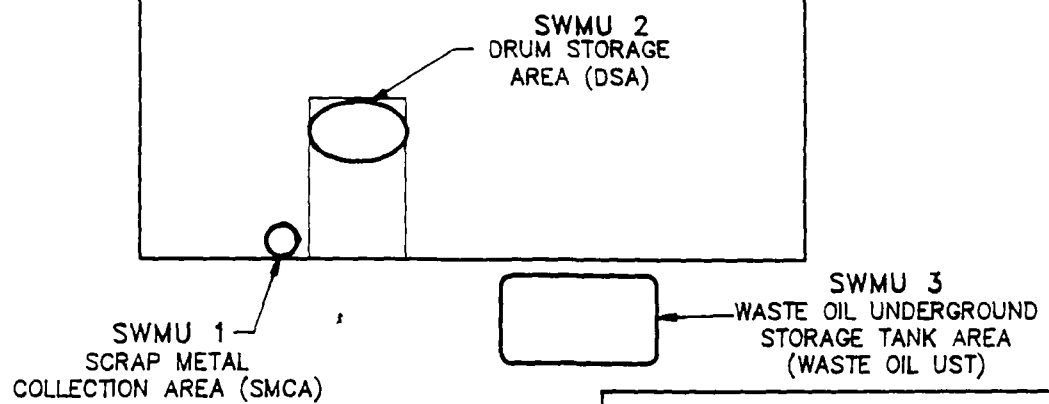
FIGURE 2
315 WEST EDGERTON AVENUE
FACILITY LAYOUT

Facility SWMUs identified during the PA/VSI include the following: (1) Scrap Metal Collection Area (SMCA) (SWMU 1); (2) Drum Storage Area (DSA) (SWMU 2); (3) Waste Oil Underground Storage Tank (Waste Oil UST) (SWMU 3); (4) Hazardous Waste Storage Area (HWSA) (SWMU 4); and (5) Aboveground Storage Tank (AST) (SWMU 5). Facility SWMUs are identified in Table 1. The facility layout is shown in Figures 2 and 3.

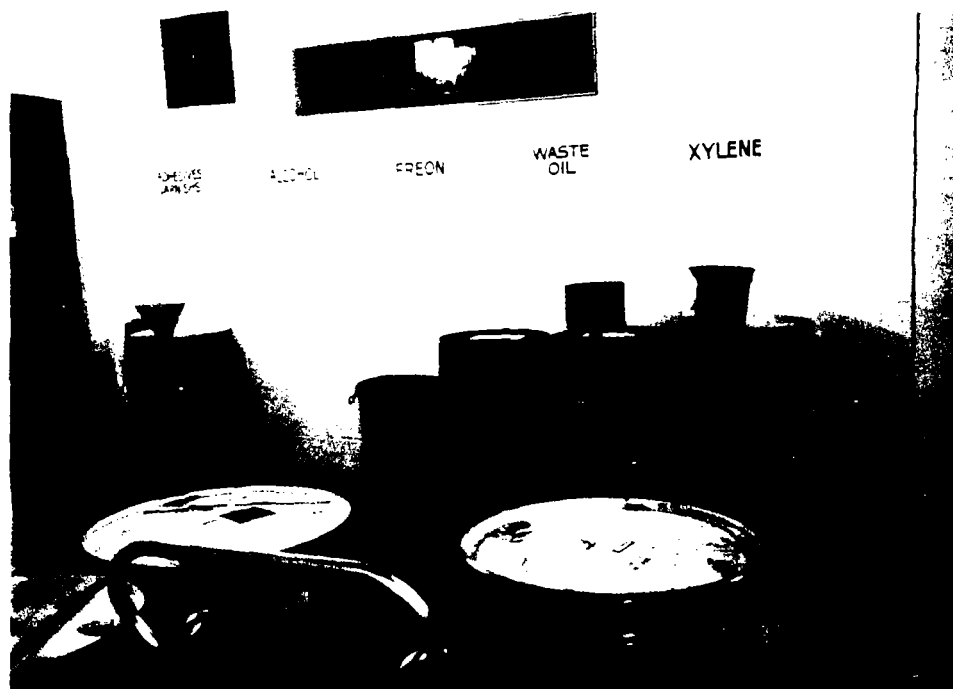
Photograph No. 1

Observations: During the VSI, the unit contained four unlabeled drums of wastes. GE Medical Systems representatives stated that the four drums contained xylene, and adhesives and resins, and oil. PRC observed no cracks in the concrete floors, and trenches were clean and free of residue. PRC observed no evidence of release.

Location: SWMU 2

Recommendations: PRC recommends that EPA advise GE Medical Systems to properly label all drums of waste.

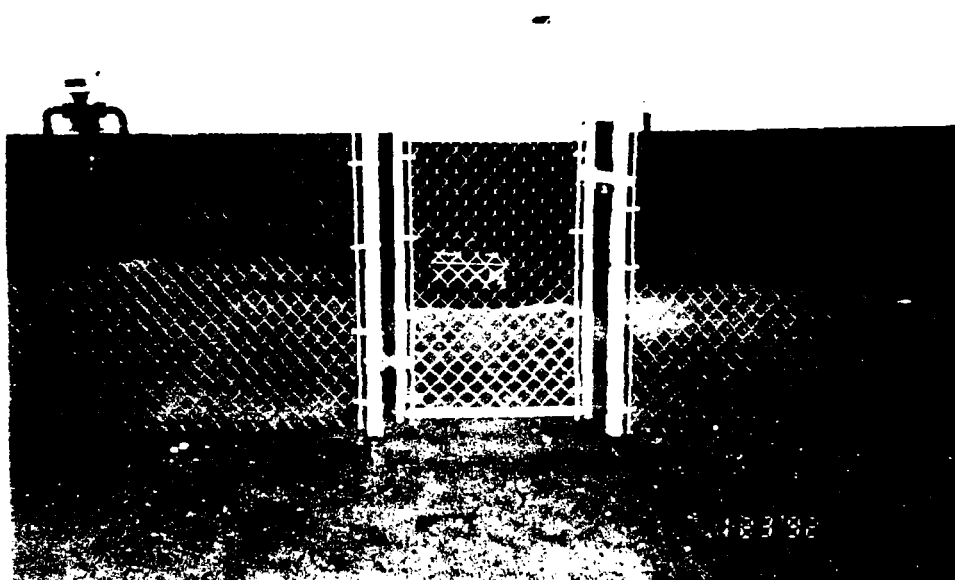
Photograph No. 2

PRC did not identify any AOC's at the facility. PRC observed a black stain above the Waste Oil Underground Storage Tank (UST) (SWMU 3). This stain was located on the concrete

that covered the area from the oil pump to the concrete masonry wall. During the VSI, all facility SWMUs appeared to have sound containment.

Conclusions: This SWMU stores nonhazardous waste transformer oil that is recycled off site. The unit has a low to medium potential for release to ground water, surface water, air, and on-site soils because an oil spill on the concrete pad may migrate through the crack between the concrete masonry wall and the concrete pad.

Location: SWMU 3

Recommendations: PRC recommends that GE Medical Systems seal the crack between the concrete masonry wall and the concrete pad. This preventive maintenance will help to ensure that oil spills in the area do not contaminate the ground below the concrete pad.

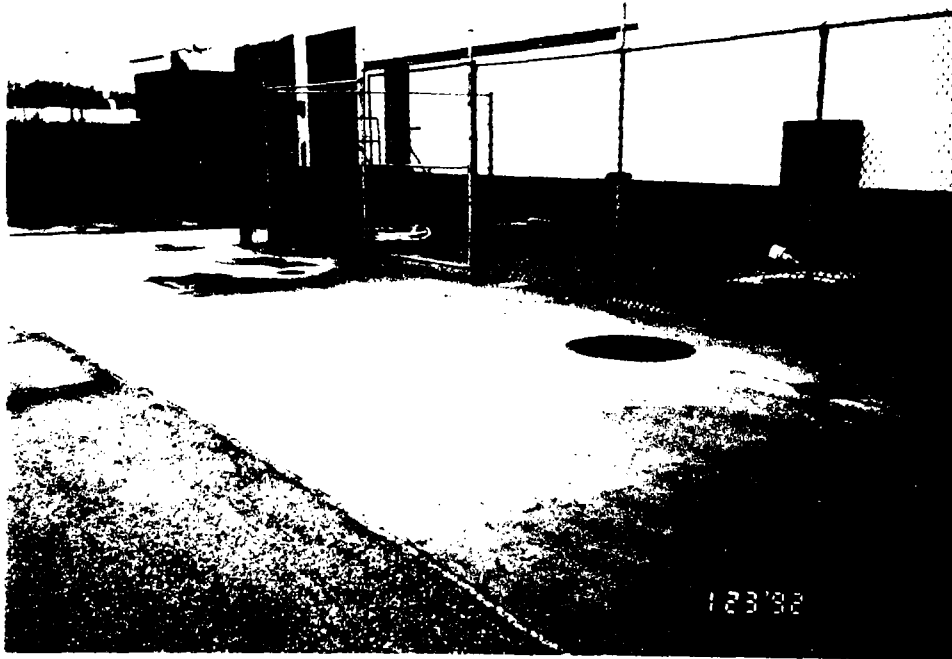
Photograph No. 3
 Orientation: Northwest
 Description: This picture shows the location of the Waste Oil UST.

Date of Startup:	This unit began operation in about 1971.
Date of Closure:	This unit is active.
Wastes Managed:	This unit manages used, nonhazardous transformer oil (no EPA codes) that is free of polychlorinated biphenyls. Wastes from this unit are ultimately recycled.
Release Controls:	This unit is located underground. The concrete pad above the tank is well maintained, and the Waste Oil UST has cathodic protection and a leak detection device (GE Medical Systems, 1992b).
History of Documented Releases:	No releases from this SWMU have been documented.
Observations:	During the VSI, PRC observed no visible cracks in the concrete pad located above the Waste Oil UST. However, PRC did observe a crack between the concrete masonry walls and the concrete pad covering the tank. PRC noted a black stain on the concrete that covered the area from the pump to the concrete masonry wall.
SWMU 4	Hazardous Waste Storage Area (300 West Edgerton Avenue)

Location: SWMU 3
 Date: 01/23/92

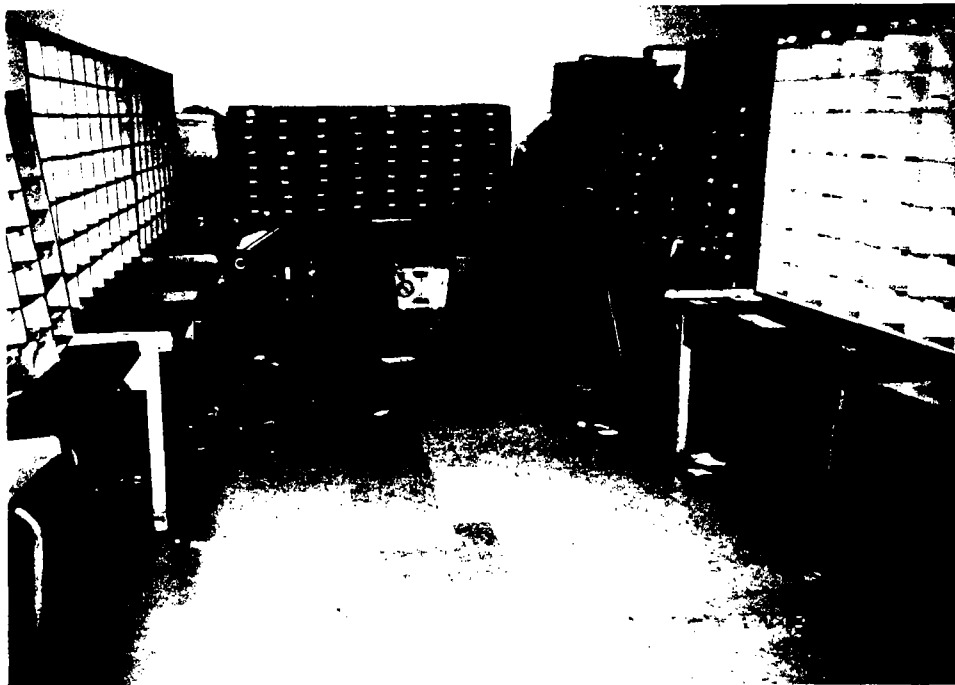
Photograph No. 4
 Orientation: East
 Description: This picture shows the approximate location of the former HWSA, now occupied by Federal Mailing Systems, Inc.

Unit Description:	This unit was located above ground and indoors. The unit measured approximately 10 feet by 15 feet and consisted of a concrete floor and concrete masonry walls (see Photograph No. 4).
Date of Startup:	This unit began operation in about 1971 (GE Medical Systems, 1992b).
Date of Closure:	This unit is inactive; WDNR approved its RCRA closure in 1989 (WDNR, 1989).
Wastes Managed:	This unit managed hazardous wastes (D001 and F002) in containers. Wastes from this unit were ultimately recycled or disposed of off site.

Conclusions: This unit stored solid and hazardous waste and WDNR approved RCRA closure in 1989. The unit had a low potential for release to ground water, surface water, air, and on-site soils. No evidence of spill or release was noted during the VSI and there are no regulatory records that state otherwise.

Location: SWMU 4
 Date: 01/23/92

Recommendations: PRC recommends no further action at this time.
